Appendix 2C
Jurisdictional Delineation

Sunset Crossings Residential Project
Initial Study

SUBJECT: Delineation of State and Federal Jurisdictional Waters for the Sunset Crossing TTM 38443 Project – City of Moreno Valley, County of Riverside, California

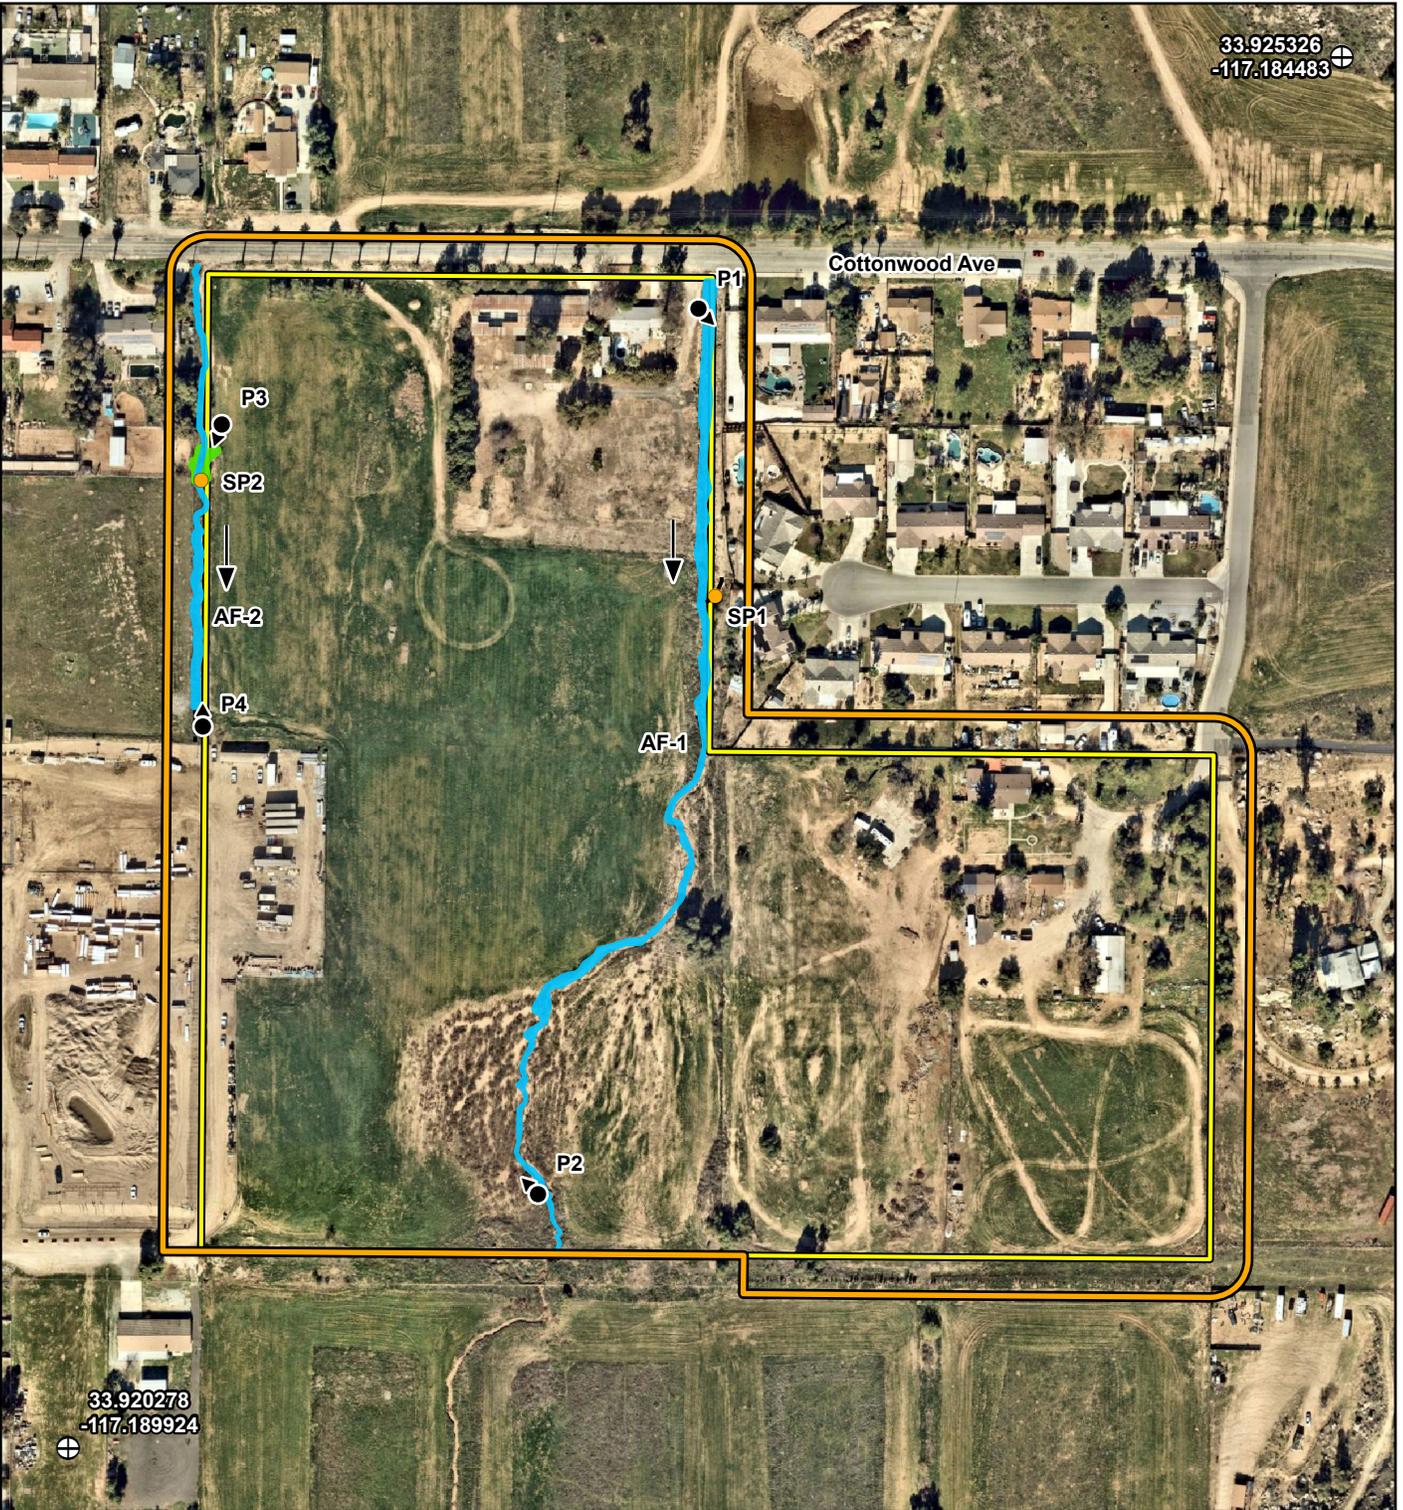
AF-1 occurs within the eastern portion of the project site and survey area and does not exhibit a surface hydrologic connection to any Relatively Permanent Water (RPW) or Traditionally Navigable Water (TNW). Flows from AF-1 continue south offsite and drain into a roadside ditch which runs easterly along the northern side of Alessandro Boulevard before emptying into a small concrete culvert. Flows from AF-1 are then conveyed onto the property south of Alessandro Boulevard via a concrete culvert where AF-1 then transitions to discontinuous unconfined/overland sheet flow which ultimately fans out and infiltrates offsite. Furthermore, AF-1 appears to be an ephemeral feature which flows only in direct response to precipitation. Therefore, AF-1 would not qualify as a WoUS and would not fall under the regulatory authority of the USACE. However, based on the results of the field delineation, AF-1 does comprise approximately 0.27 acre (1,444 linear feet) of RWQCB non-wetland waters of the State/CDFW vegetated streambed (consisting of 0.27 acre located within the project site and an additional <0.01 acre located within the survey area). Refer to Table 1 below and Figure 4, *Regional Board/CDFW Jurisdictional Map* provided in Attachment A).

Project Site (29.39 acres)	CDFW Associated Riparian Vegetation (0.02 acre)	Discontinuous OHWM	Photograph Point and Direction
Survey Area (34.66 acres)	Regional Board Non-Wetland Waters of the State / CDFW Vegetated Streambed (0.37 acre)	Flow Direction	Soil Pit
Reference Point

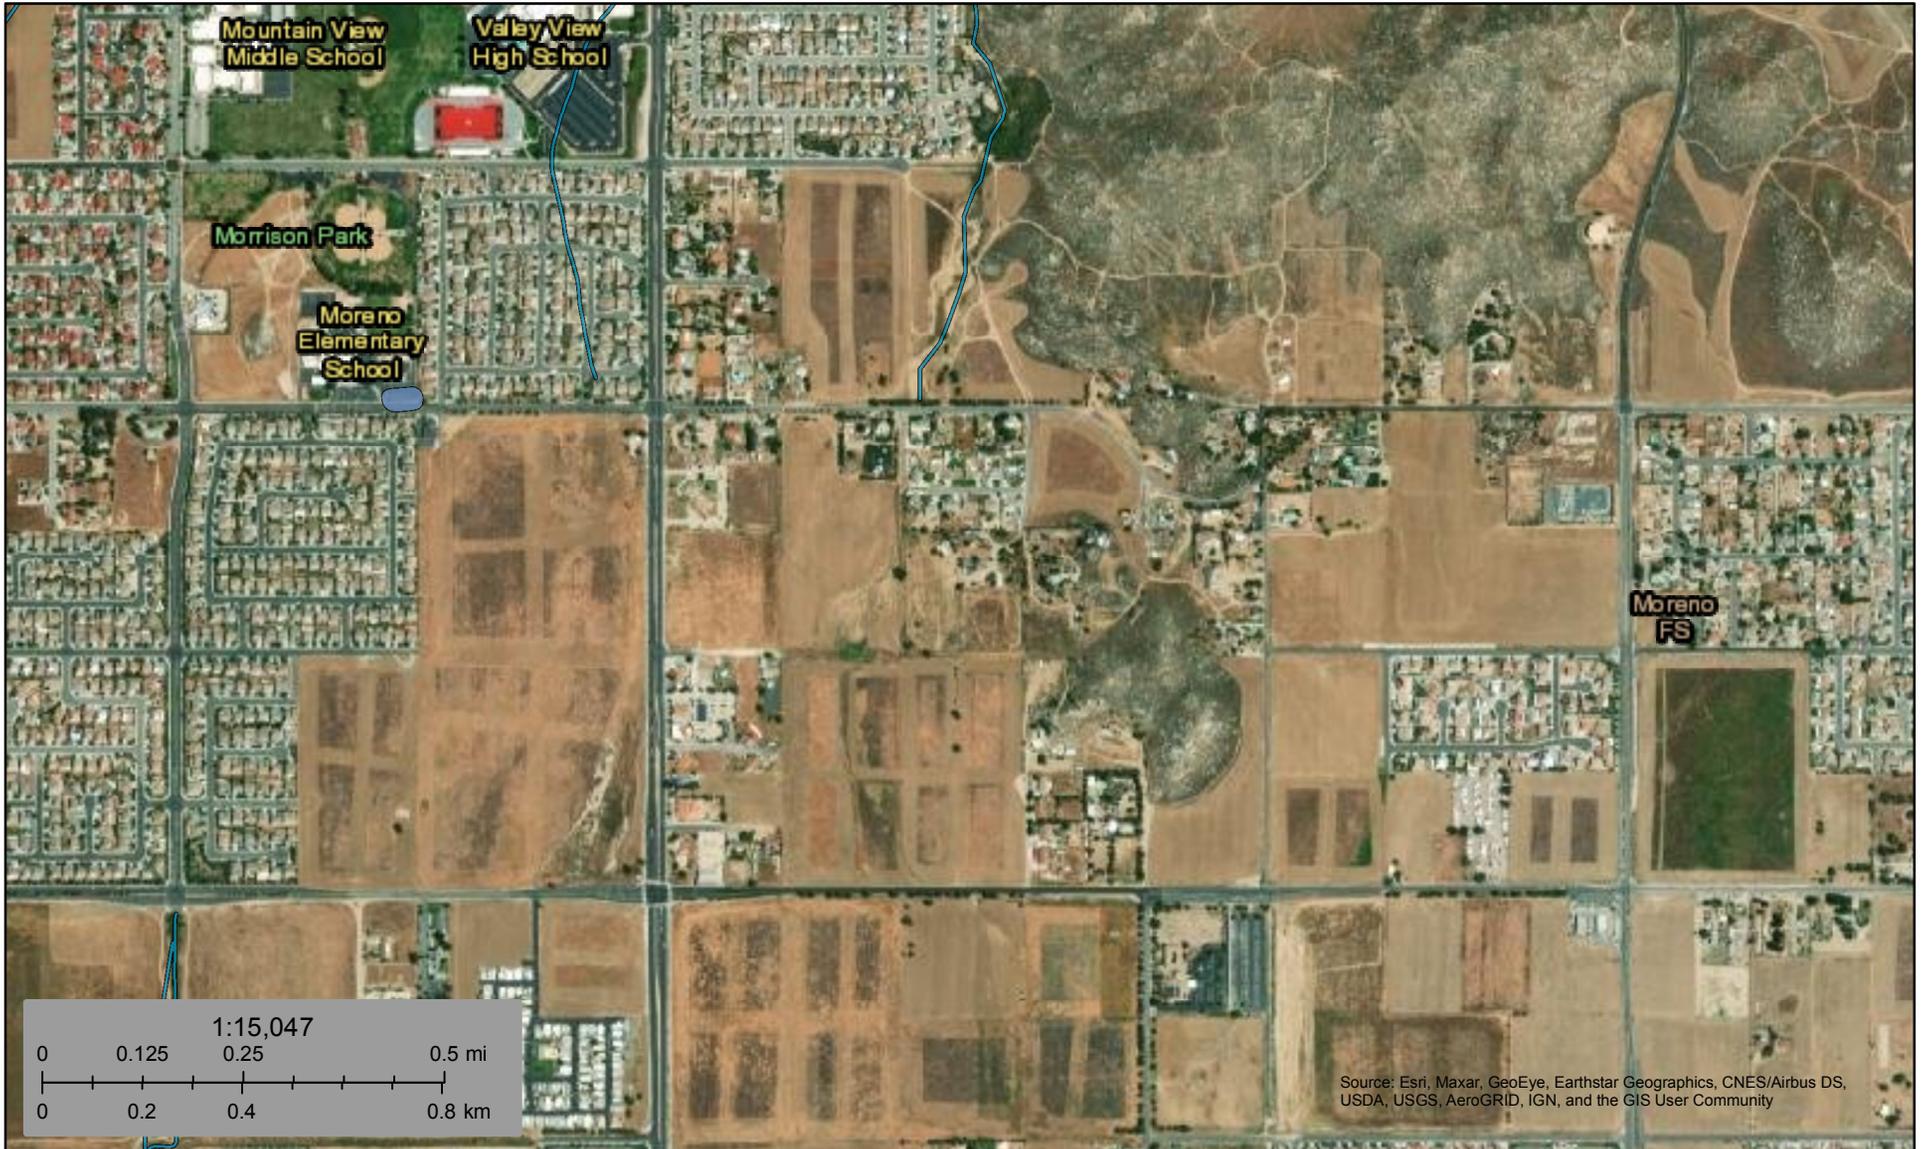
USFWS National Wetlands Inventory Map

Based on a review of the U.S. Fish and Wildlife Service’s (USFWS) National Wetlands Inventory (USFWS 2022), no riparian or wetland features mapped in the NWI directly overlay the project site. However, one feature is mapped immediately northeast of the project site and connects to Aquatic Feature 1 downstream; this wetland feature falls within the riverine system and is described as an intermittent streambed with a seasonally flooded water regime (R4SBC).

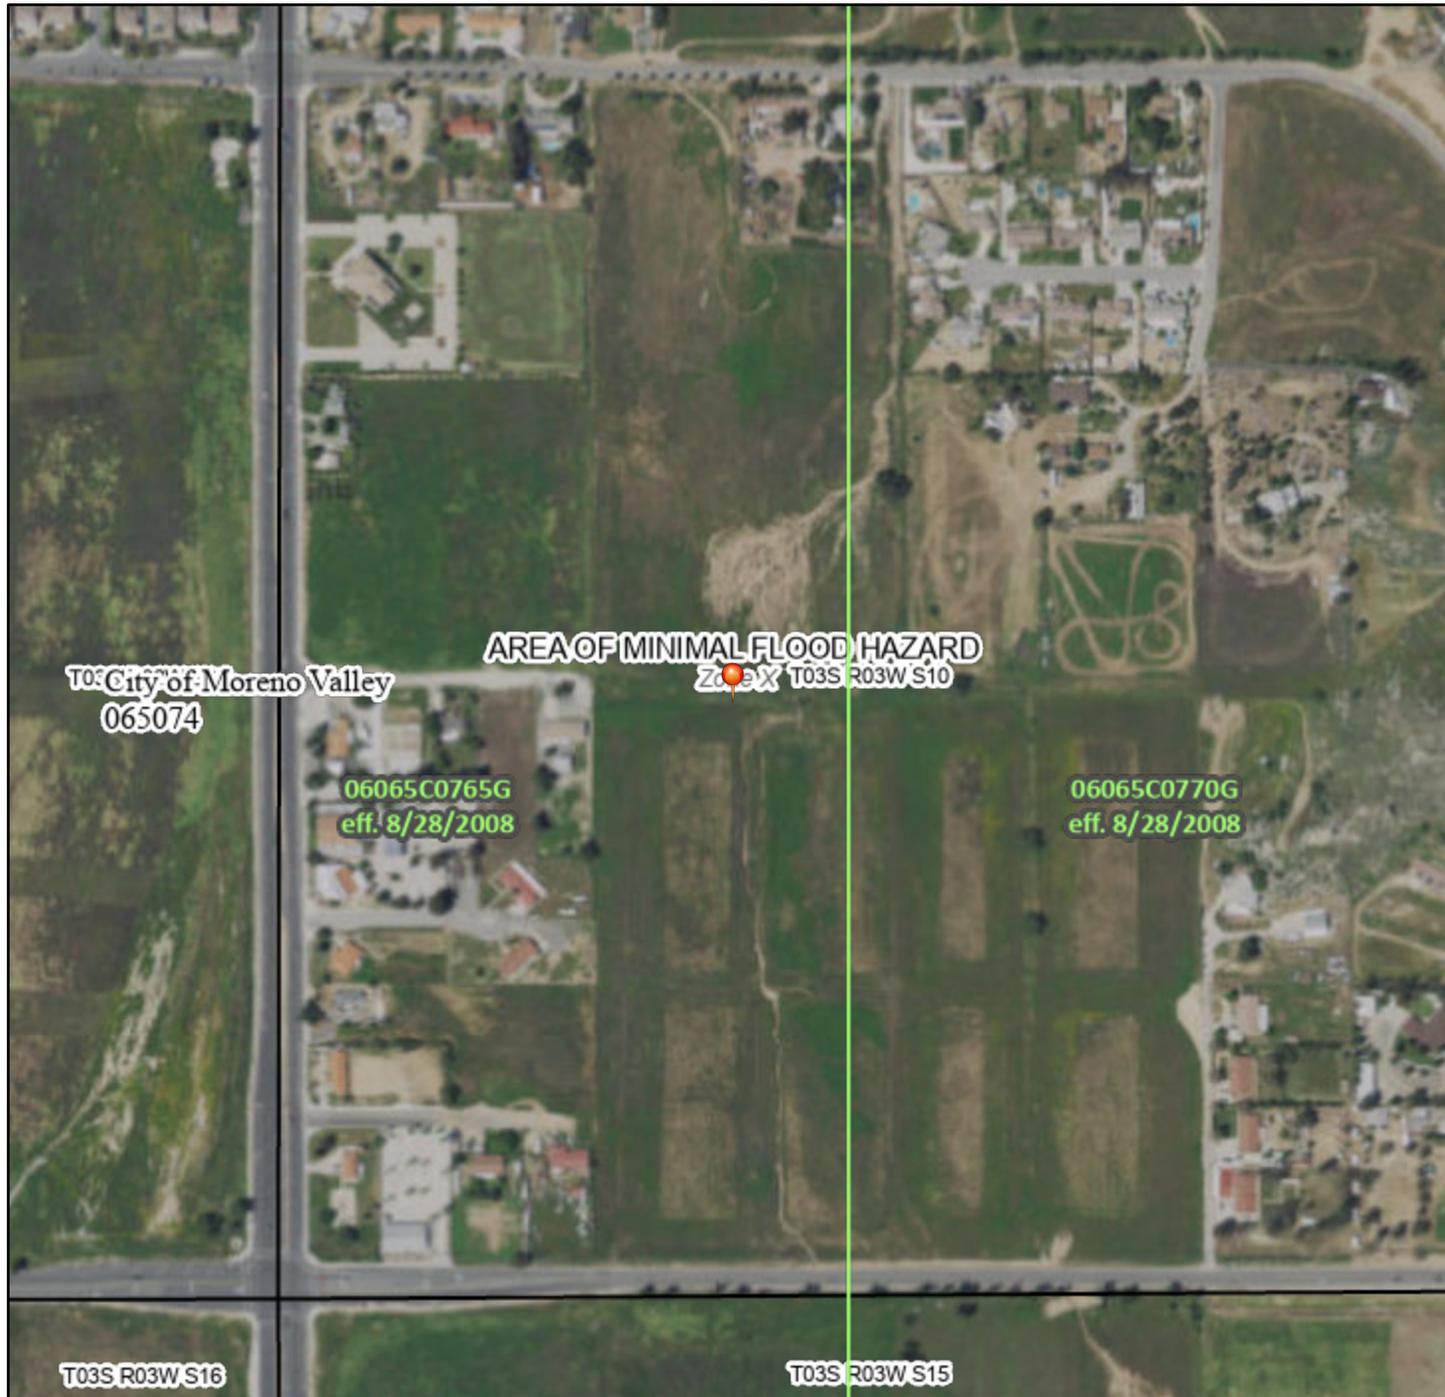
FEMA Flood Insurance Rate Map

Based on a review of the Federal Emergency Management Agency’s (FEMA) National Flood Hazard Layer Viewer (FEMA 2022), the project site is located within Flood Insurance Rate Map (FIRM) Panel Number 06065C0770G. Specifically, the project site is located in Zone X and described as an area of minimal flood hazard (refer to Attachment C).

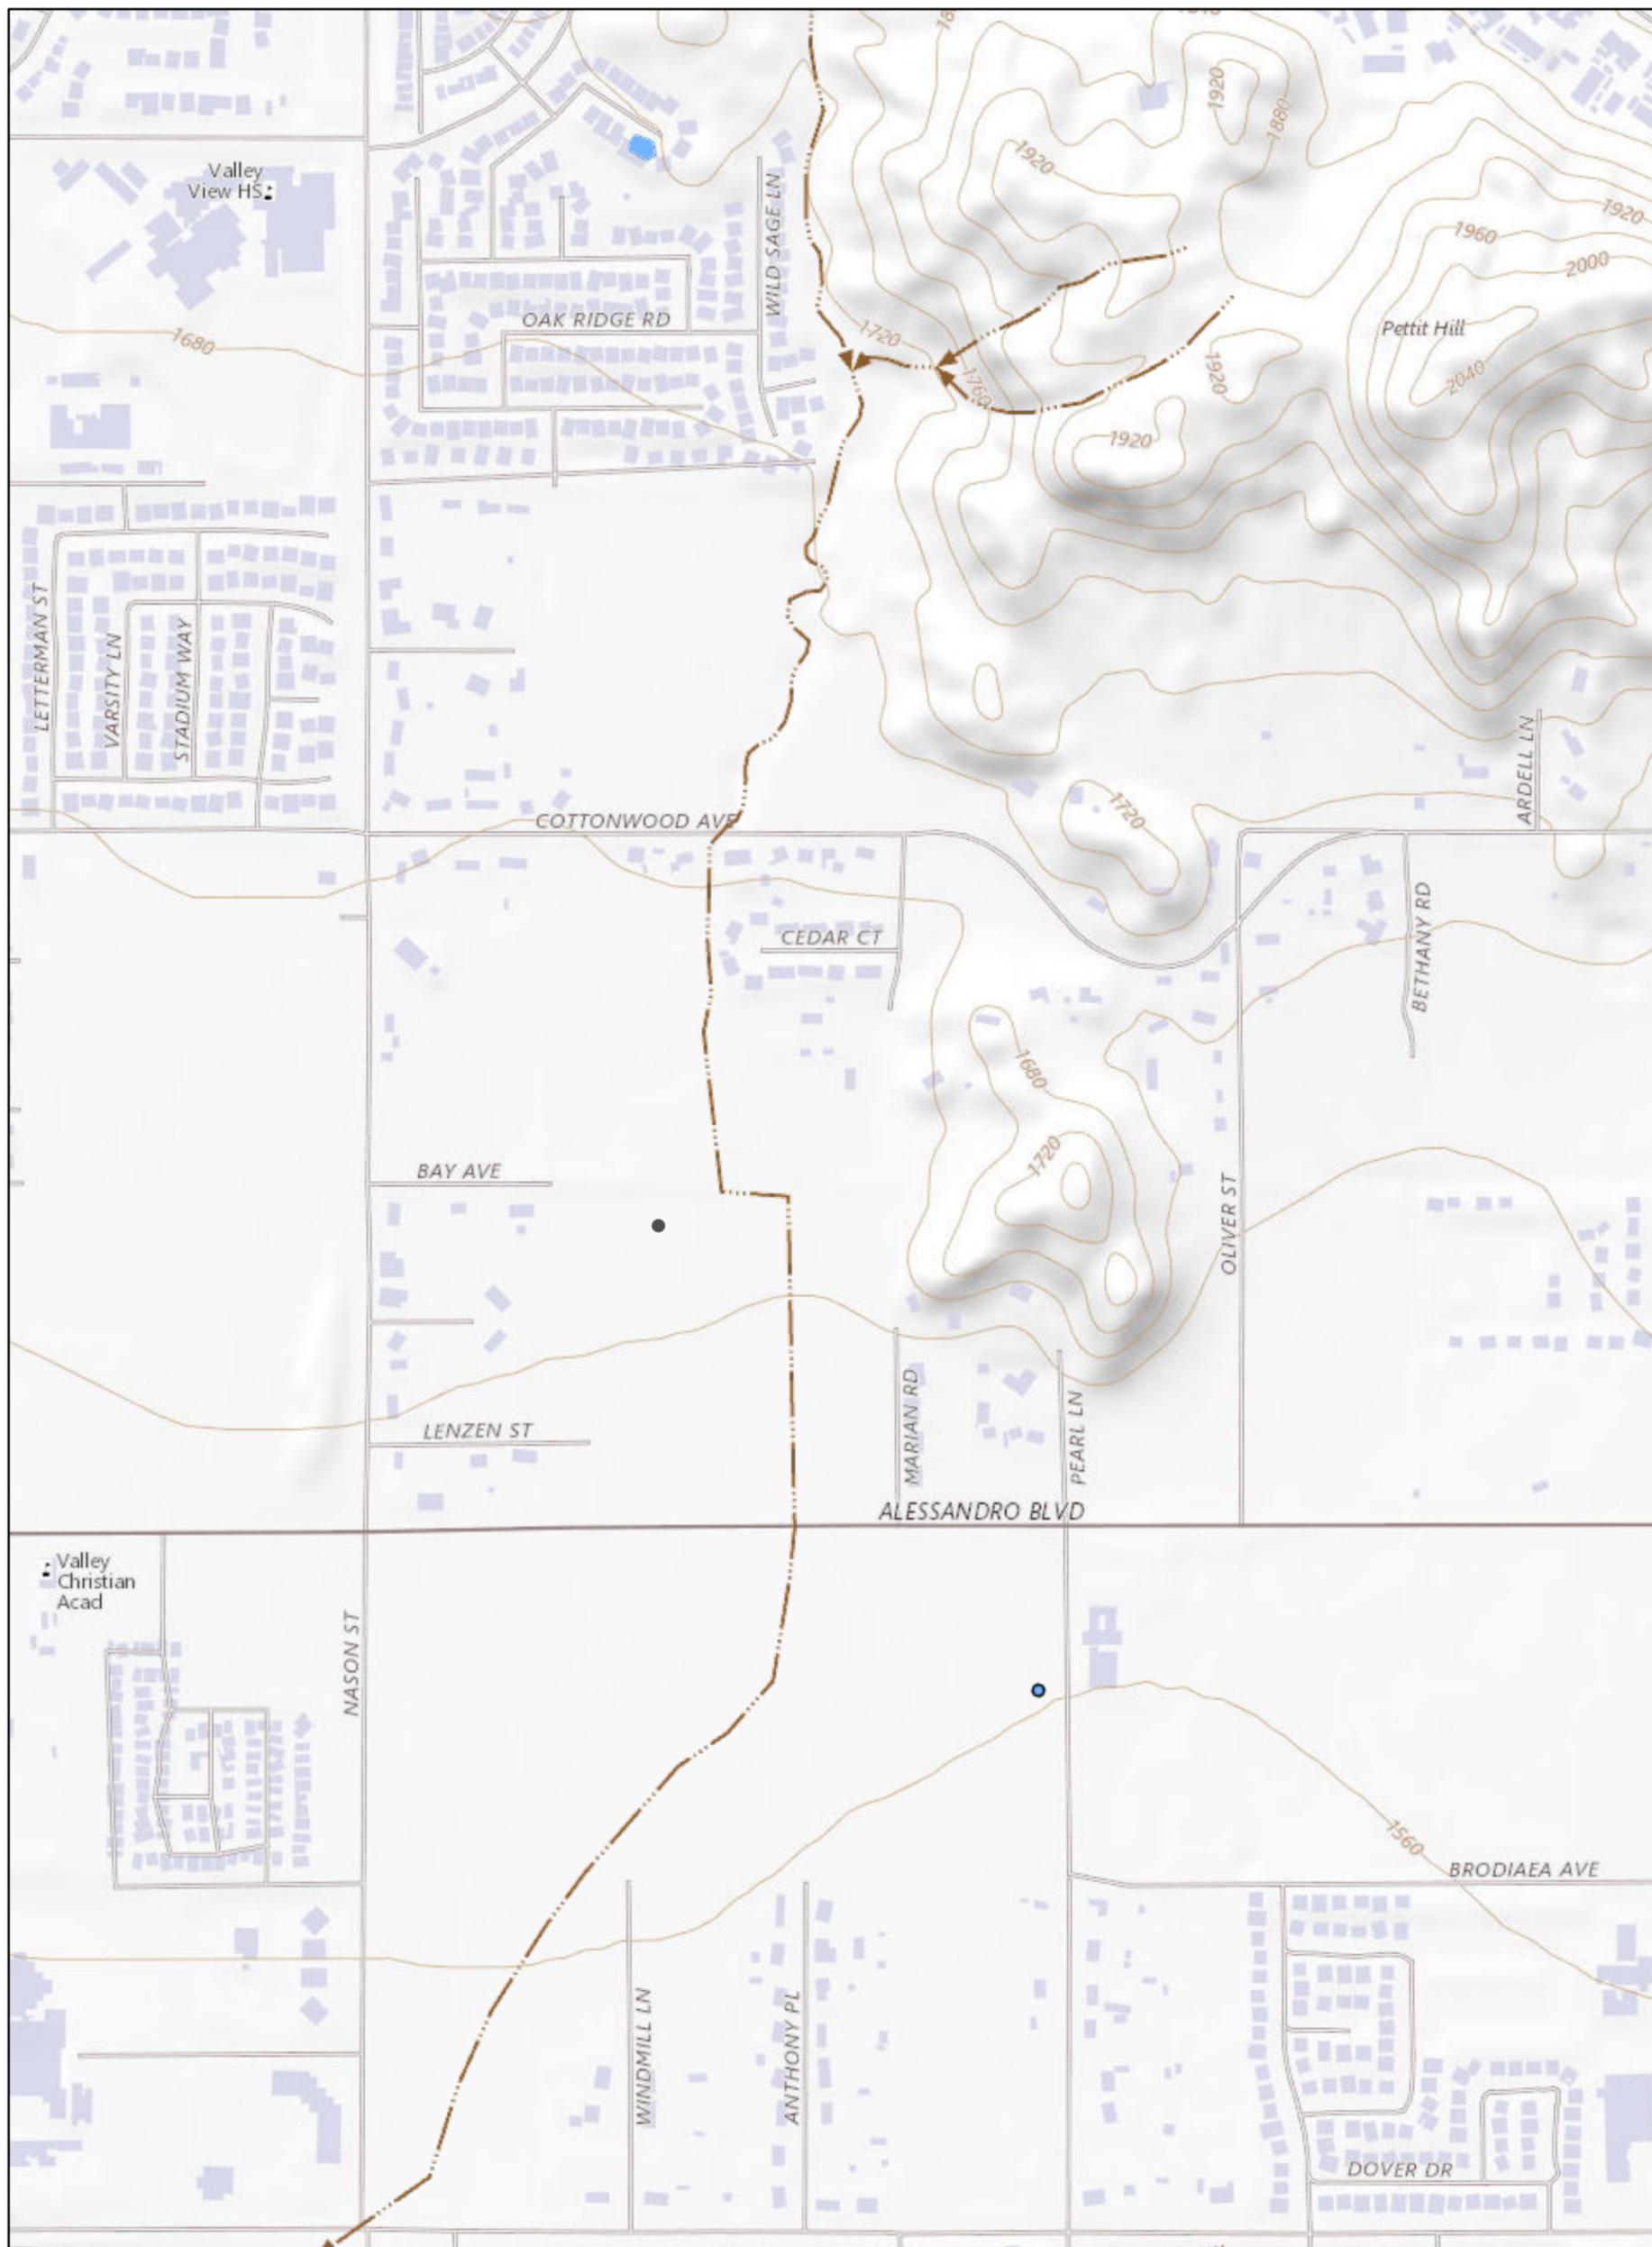
USGS National Hydrography Dataset Advanced Viewer Map

Based on a review of the National Hydrography Dataset (NHD) Advanced Viewer (USGS 2022b), one ephemeral drainage enters the northeastern corner of the project site and flows generally south before continuing offsite. The upstream portion of this ephemeral feature immediately northeast of the project site appears to coincide with the offsite riverine feature mapped by the NWI (refer to Attachment D).

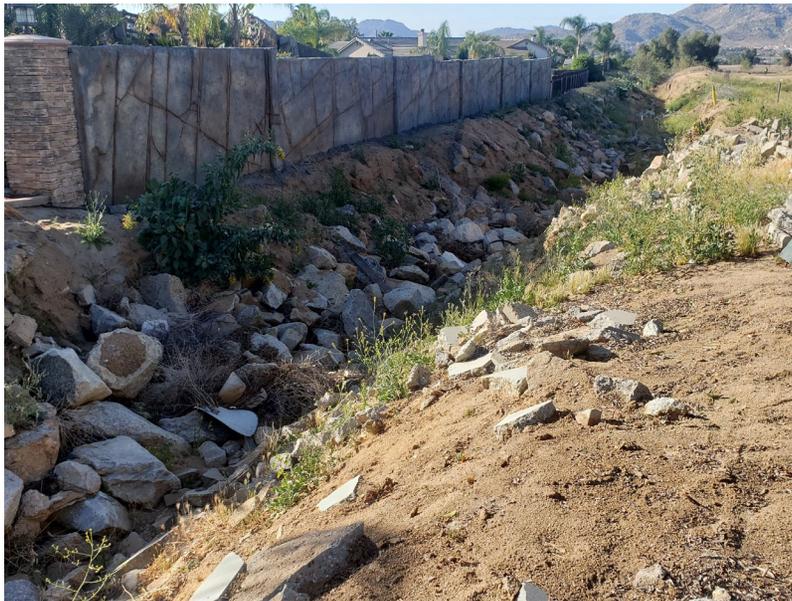
AF-1 collects/transportes municipal stormwater from the adjacent residential development and surrounding foothills north of the project site, undergrounds beneath Cottonwood Avenue, and discharges into the northeastern corner of the project site and survey area via a corrugated concrete pipe culvert with concrete wingwalls. The offsite upstream portion of AF-1 appears to be the feature that has been mapped by both NWI and NHD. Flows drain south into a riprap-lined flood control channel which is confined by residential development on both banks. Approximately 360 linear feet downstream, AF-1 begins to transition from the riprap-lined flood control channel to an incised earthen channel. A small culvert with concrete wingwalls is located on the eastern bank in this transitional area. At the time of the site visit, the culvert was obstructed by sediment resulting in a small erosional rill. A minimal amount of saturated soil and surface water were noted in the immediate location of the obstructed culvert and rill on the eastern bank, but not within the main channel bed or the surrounding banks. No other standing or flowing water was observed in association with AF-1.

Photograph 1: View facing approximately southeast depicting AF-1 where it enters the project site.

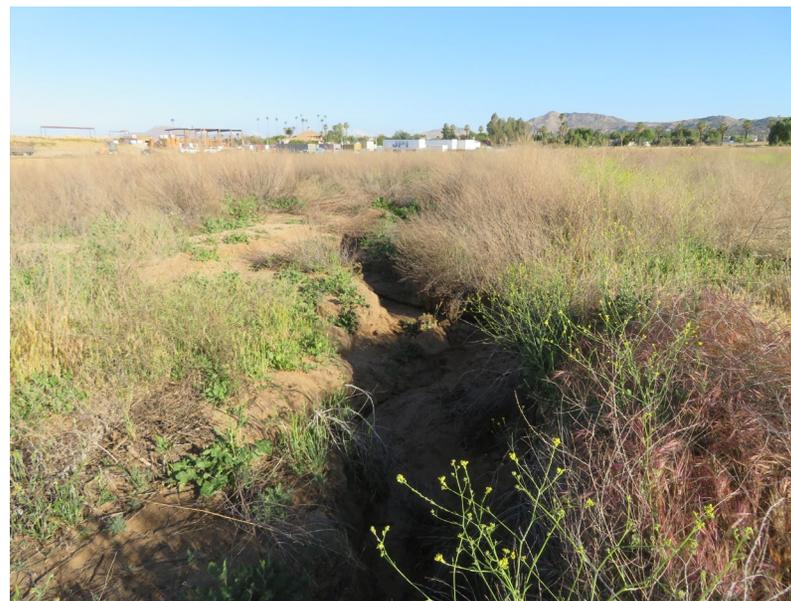
AF-1 continues south for approximately 180 linear feet and then begins to meander southwest towards the southern project boundary where it is no longer constrained by residential development on either bank. A large concrete retaining wall is located along the southern project site boundary and flows appear to be conveyed beneath this retaining wall, likely via a pipe or culvert; however, a significant amount of sediment deposition has occurred in the immediate vicinity of the retaining wall which reduces visibility. Additionally, a large debris-filled non-jurisdictional erosional rill occurs immediately northwest of where AF-1 flows beneath the retaining wall and exits the project site and survey area. AF-1 exhibited clear

evidence of hydrology and an OHWM ranging from 2 to 25 feet in width was observed via the following indicators: via a natural line impressed on the bank, change in particle size distribution, presence of a wrack line, and shelving.

The riprap-lined and soft-bottomed portions of AF-1 exhibited similar vegetation comprised of upland disturbance-tolerant non-native plant species consistent with the surrounding uplands; however, these species generally occurred in sparser patches within AF-1. Dominant species included foxtail barley (*Hordeum murinum*, FACU), foxtail brome (*Bromus rubens*, UPL), red stemmed filaree (*Erodium cicutarium*, UPL), ripgut brome (*Bromus diandrus*, UPL), sagebrush combseed (*Pectocarya linearis*, UPL), stinknet (*Oncosiphon piluliferum*, FACU), and summer mustard (*Hirschfeldia incana*, UPL). Additionally, a small amount of hydrophytic vegetation comprised of tall flatsedge (*Cyperus eragrostis*, FACW) and willowherb (*Epilobium ciliatum*, FACW) was observed in association with the obstructed culvert on the eastern bank. Within the project site and survey area, AF-1 measures a total of approximately 1,444 linear feet.

Photograph 2: View facing approximately northwest depicting typical conditions within AF-1.

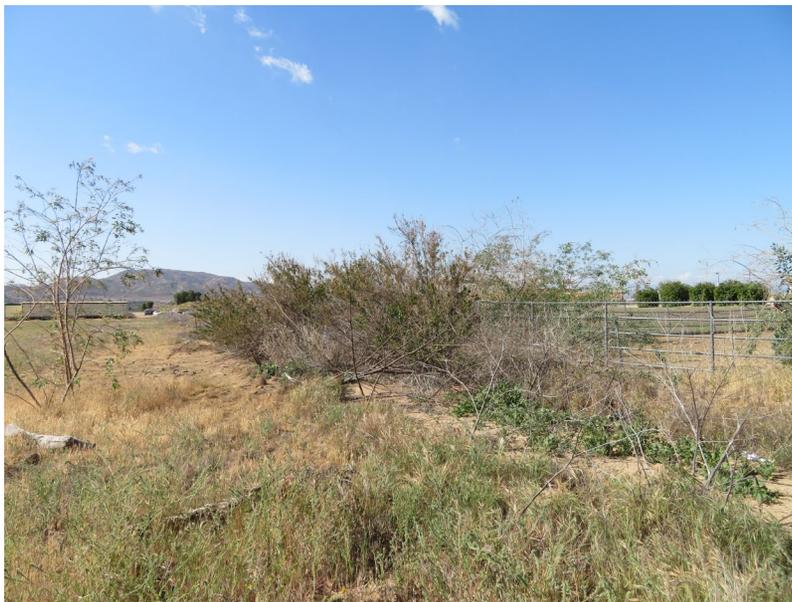
AF-2 originates offsite as an ephemeral drainage which drains stormwater and other surface flows from the surrounding residential developments and foothills north of the project site; flows are conveyed south via a corrugated metal pipe underneath Cottonwood Avenue and enter the northwestern portion of the project site and survey area via a corrugated metal pipe with broken concrete wingwalls. AF-2 flows south for approximately 611 linear feet as an unmaintained ephemeral earthen drainage before transitioning to discontinuous unconfined/overland sheet flow which ultimately fans out and infiltrates on the northwestern portion of the project site. No standing or flowing surface water was observed within the AF-2 during the field survey. However, evidence of an OHWM ranging from 5 to 10 feet in width was observed via a natural line impressed on the bank, change in particle size distribution, presence of a wrack line, and shelving.

AF-2 exhibited the same upland vegetation as AF-1 with a predominance of ripgut brome and summer mustard and occasional patches of bare sandy soil. A patch of Peruvian pepper trees (*Schinus molle*, FACU) occurs in the northern portion of AF-2 in association with the residential development immediately to the west. Additionally, a small patch of mature mulefat (*Baccharis salicifolia*, FAC) occurs approximately 230 feet downstream of where AF-2 enters the project site and survey area.

Photograph 3: View facing approximately southwest depicting AF-2. Note the small amount of *Baccharis salicifolia* located within the feature.

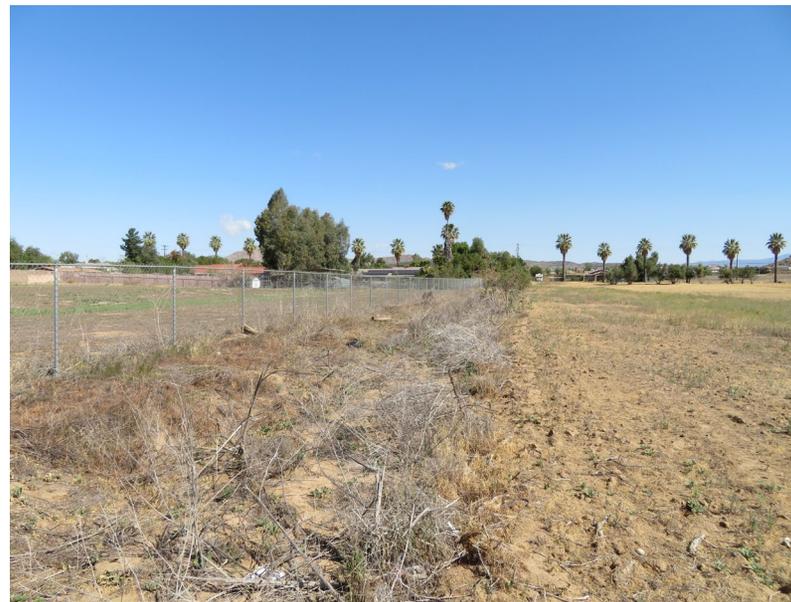
AF-2 occurs within the northwestern portion of the project site and survey area and also does not exhibit a surface hydrologic connection to any RPW or TNW. Flows from AF-2 transition to discontinuous unconfined/overland sheet flow which ultimately fans out and infiltrates within the western portion of the project site. Furthermore, AF-2 appears to be an ephemeral feature which flows only in direct response to precipitation. Therefore, AF-2 would not qualify as a WoUS and would not fall under the regulatory authority of the USACE. However, based on the results of the field delineation, AF-2 does comprise a total of 0.10 acre (611 linear feet) of RWQCB non-wetland waters of the State/CDFW vegetated streambed (consisting of <0.001 acre located within the project site and an additional 0.10 acre located within the survey area), and approximately 0.02 acre of CDFW associated riparian (consisting of <0.01 acre located within the project site and an additional 0.02 acre located within the survey area).

Photograph 4: View facing approximately north depicting the location where AF-2 transitions to discontinuous flow and terminates within the project site.
